Projectile Cylinder Accidents Resulting from the Presence of Ferromagnetic Nitrous Oxide or Oxygen Tanks in the MR Suite

AJR 2001;177:27–30

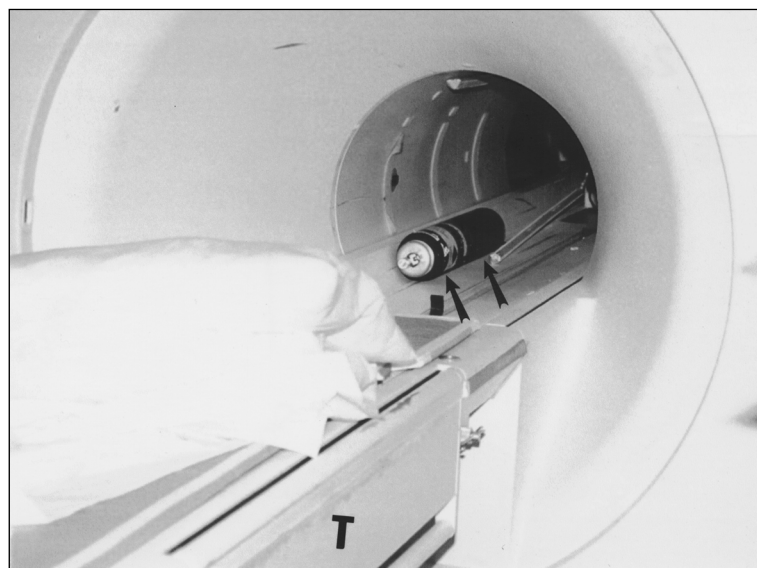
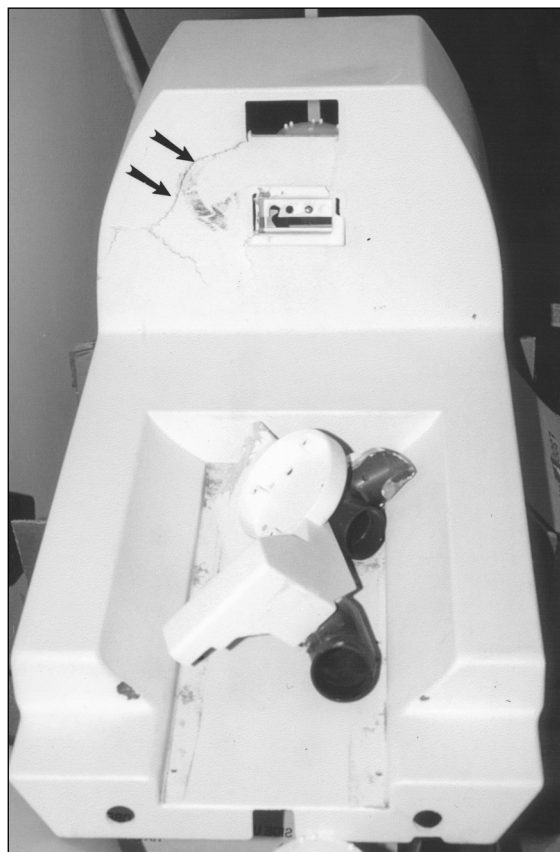
Coincidentally, and unrelated to the clinical activities, preventative maintenance was being performed on the MR imaging-compatible anesthesia machine, which was outside of the immediate magnetic imaging suite. When the work was finished, the serviceman returned the unit to the MR imaging suite. Without thinking, the serviceman had placed a non-compatible ferromagnetic nitrous oxide E-cylinder tank (the most commonly used tank on anesthesia units, 10.8 cm in diameter and 66 cm long) on the machine. Realizing his mistake, he disconnected the ferromagnetic nitrous oxide tank from the MR anesthesia cart and attempted to walk out of the magnetic field with the tank under his arm. The magnetic force pulled the cylinder from the serviceman's arm and sent it flying across the room. It narrowly missed the technologist and slammed into the front panel of the magnet (Fig. 1). The patient, MR technologist, and equipment serviceman were not injured, but the projectile collision resulted in \$50,000 damage to the magnet and loss of 1 week's imaging time.

Fig. 1.—Photographs show aftermath of incident 2, which occurred at first institution.
A, Portable anesthesia tank of nitrous oxide (*arrows*) lies in bore of 1.5-T MR unit. T = table.
B, Head coil carriage and surface coil connection box have been dislodged from table. Note cylinder mark and cracks in plastic (*arrows*).

Controlled exit and entry sites at MR imaging facilities, perhaps with a keyless electronic coded entry system, could have avoided the first incident we describe. Incident 2, involving the nitrous oxide tank, could have been avoided by adhering to protocols that allow preventive maintenance and housekeeping personnel to enter the MR suite only after proper safety education and when no patient is in the suite. Busy MR imaging schedules, a high volume of patient and personnel traffic, and perhaps a relaxed awareness of safety issues contributed to this accident.

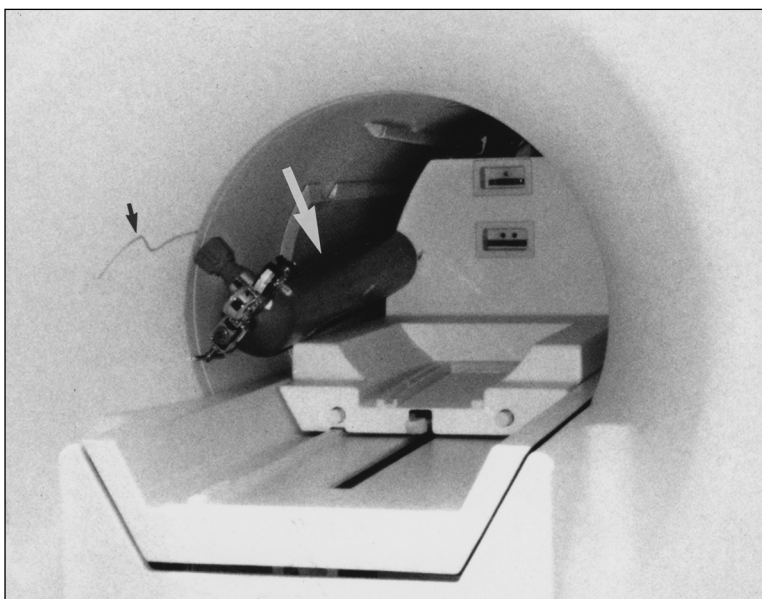
secure the oxygen tank, which was precariously stuck beneath the scanner table and stretcher. The patient was then safely removed from the scanner room. The rescue team, realizing that they could not move the oxygen tank against the pull of the magnet, decided to guide it in a controlled manner toward the bore of the magnet. This was accomplished after releasing the remaining oxygen in the cylinder and removing the head coil from the bore of the magnet to prevent damage. The posterior edge of the oxygen tank lodged against the head coil cradle and the lateral margin of the cylinder flattened against the opening of the bore (Fig. 2).

Fig. 2.—Photograph depicts result of incident 3, which occurred at second institution. H-cylinder (white arrow) lies within bore of 1.5-T MR magnet lodged against head coil carriage. Note trail of paint along bore opening (black arrow), which is only visible damage to scanner.

Field engineers from the manufacturer, acquainted with the magnet's construction and current safety approaches, responded to the situation with a plan to extract the cylinder without quenching the magnet. A rope was secured around the valve of the oxygen cylinder at one end and to a 2 in \times 4 ft (5.08 cm \times 1.22 m) wooden stud at the other end. With sufficient slack in the rope, the stud was positioned outside of the scanner door while three engineers combined their pulling strength on the stud. As the oxygen tank hovered outside the bore, a sheet of plywood was placed over the opening of the bore in case the makeshift system failed. The cylinder was then safely removed without quenching the magnet. The scanner was tested and found to function within normal parameters. This incident resulted in a 1-day loss of imaging time.
